U.S. ENVIRONMENTAL PROTECTION AGENCY  
POLLUTION/SITUATION REPORT  
American Zinc Products Fire - Removal Polrep  
Initial and Final Removal Polrep

**Subject:** POLREP #1  
Initial and Final  
American Zinc Products Fire

Mooresboro, NC  
Latitude: 35.1916330 Longitude: -81.8488390

**Date:** 5/1/2019

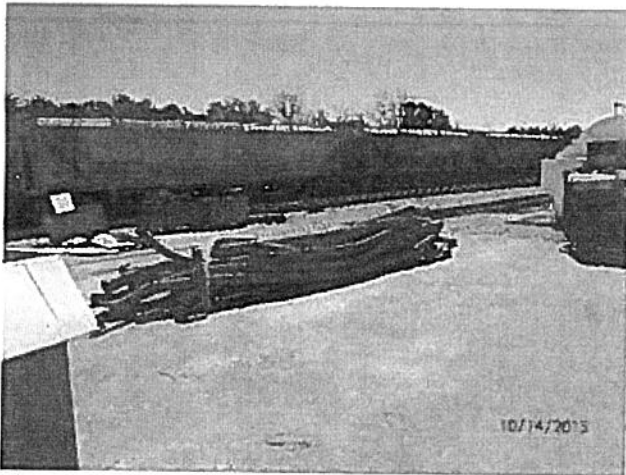
**Pursuant to 15A NCAC 13A.0110 as referenced in 15A NCAC 13A.0107 [40 C.F.R. § 265.173(a) as referenced in 40 C.F.R. § 262.34(c)(1)(i)], a generator may accumulate as much as 55 gallons of hazardous waste or one quart of acutely hazardous waste listed in §261.31 or §261.33(e) in containers at or near any point of generation where wastes initially accumulate which is under the control of the operator of the process generating the waste, without a permit or interim status and without complying with paragraph (a) or (d) of this section provided he complies with § 265.173(a) of this chapter in such that a container holding hazardous waste must always be closed during storage, except when it is necessary to add or remove waste. The two trash containers of hazardous waste were open.**

Picture 6 – Rail Yard hazardous waste debris open container

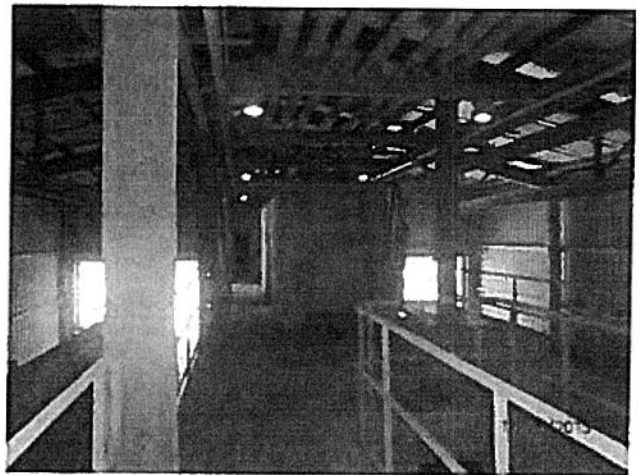
**Pursuant to 15A NCAC 13A.0110 as referenced in 15A NCAC 13A.0107 [40 C.F.R. § 265.173(a) as referenced in 40 C.F.R. § 262.34(a)(1)(i)], except as provided in paragraphs (d), (e), and (f) of this section, a generator may accumulate hazardous waste on-site for 90 days or less without a permit or without having interim status, provided that the waste is placed in containers and the generator complies with the applicable requirements of subpart I of part 265 of this chapter in such that a container holding hazardous waste must always be closed during storage, except when it is necessary to add or remove waste. The spent hoses, a hazardous waste, were not contained.**

**Pursuant to 15A NCAC 13A.0107 [40 C.F.R. § 262.34(a)(2) and (a)(3)], except as provided in paragraphs (d), (e), and (f) of this section, a generator may accumulate hazardous waste on-site for 90 days or less without a permit or without having interim status, provided that the date upon which each period of accumulation begins is clearly marked and visible for inspection on each container; and while being accumulated on-site, each container and tank is labeled or marked clearly with the words, "Hazardous Waste". The spent hoses, a hazardous waste, were not labeled or marked with an accumulation start date.**

Picture 7 – Rail Yard spent hoses contaminated with WOX

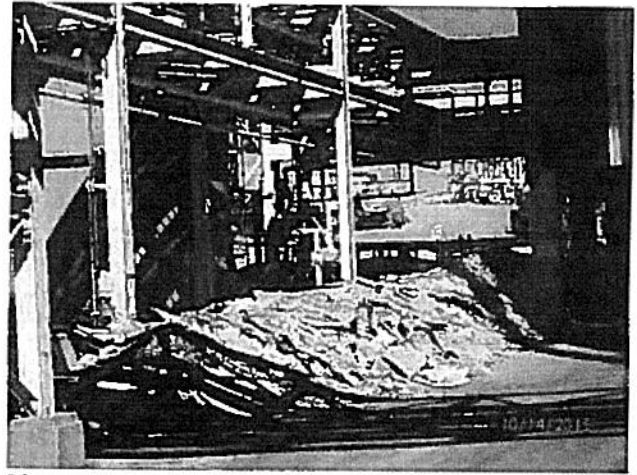
Also in this area, the inspectors observed spent aluminum cathodes from the Electro-winning Area staged to be cleaned (Pictures 25-26), and a pile of zinc clean out material from the bottom of the cellhouse (Pictures 27-28). Mr. Harris stated that the zinc clean out material will be placed into a roll-off and put into the dross recycling process.

Picture 27 – Cellhouse zinc clean out material

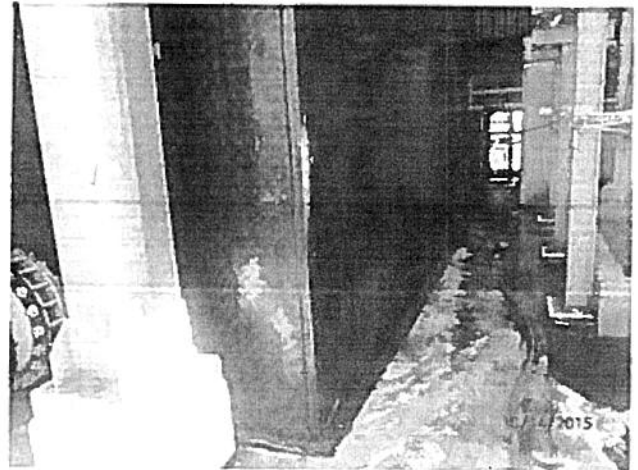
Picture 28 – Cellhouse zinc clean out material

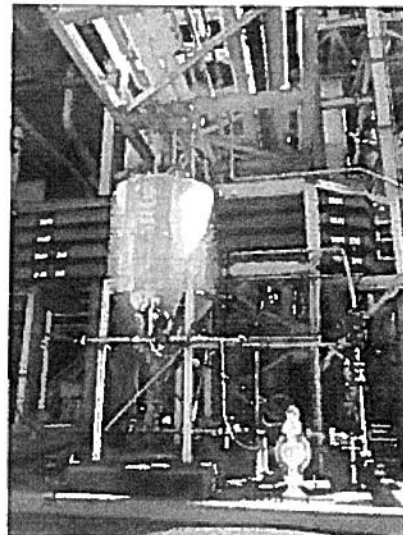
The inspectors then examined the Recirculation Tank (Picture 29) and secondary containment. The secondary containment was storing rainwater, electrolytes, sulfuric acid (which exceeded the reportable quantity), wash water, drips and overflow. The inspectors observed that this liquid had seeped between the tank and the floor seal. The high pH water flowed from the secondary containment into the storm water drain, into Basin 1 and out the storm water discharge pipe. HHMP determined the cause of the seepage was the improperly installed sealant between the floor and the tank. The sealant had eroded away because of the high pH.

The situation was further impaired by the north side sump pump failing and the process water rising higher than normal in the secondary containment area. HHMP stated that the leak was detected in a drain on September 5, 2015, however, the source was not discovered until September 8, 2015. Roll-offs of hazardous and non-hazardous waste from the Recirculation Tank spill are located near the depleted solution area.

Picture 29 – Recirc Tank – failure area

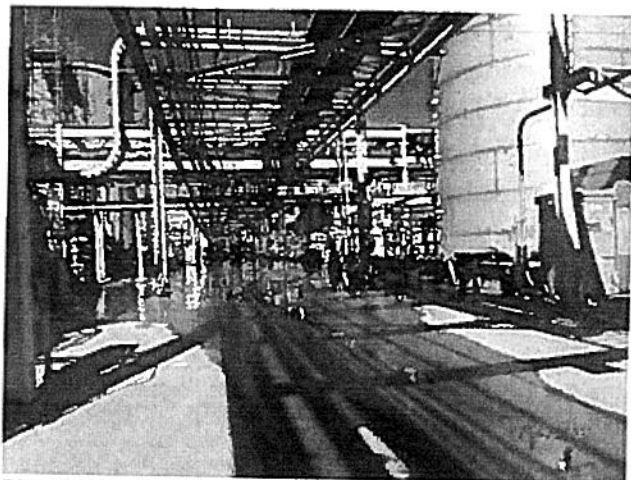
The inspectors observed a silver tank labeled "Waste Acid Slurry Tank" (Picture 30). When asked about the contents of the tank, Mr. Harris explained that the tank was labeled incorrectly and it should be called "Excess Acid Slurry Tank." The tank is used to capture and store the extra acid slurry from the Electro-winning process.

Picture 30 – Waste Acid Slurry Tank

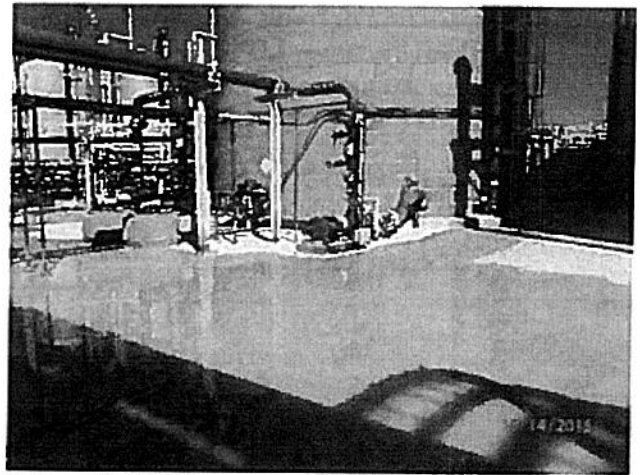
The 100 Area main secondary containment was observed covered in unknown dust and mud (Pictures 42-44). When asked, Mr. Harris explained that dust and mud was residue from the Reactors, the Leach Residue Press and other processes. The inspectors expressed concern that the residue containing cadmium, lead, and silver was being tracked out of the area and around the facility. In addition, the discarded residue was not being used for its intended purpose, thus making the residue on the ground of the 100 Area main secondary containment a hazardous waste.

Picture 43 – 100 Area main secondary containment covered in unknown dust and mud

**Pursuant to 15A NCAC 13A.0107 [40 C.F.R. § 262.11], a person who generates a solid waste, as defined in 40 C.F.R. § 261.2, must determine if residue dust and mud on the ground of the 100 Area main secondary containment is a hazardous waste.**

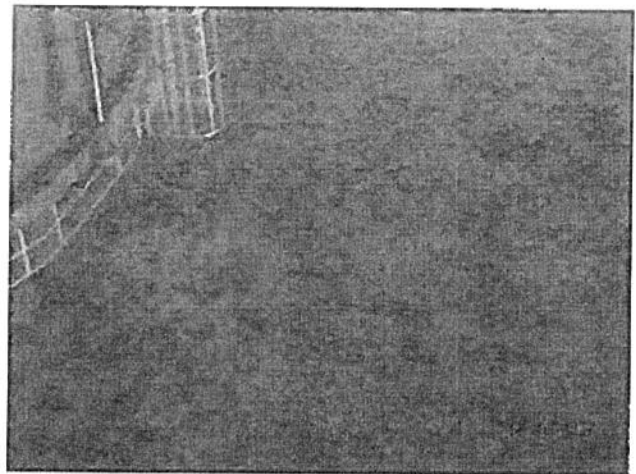
Picture 44 – 100 Area main secondary containment covered in unknown dust and mud

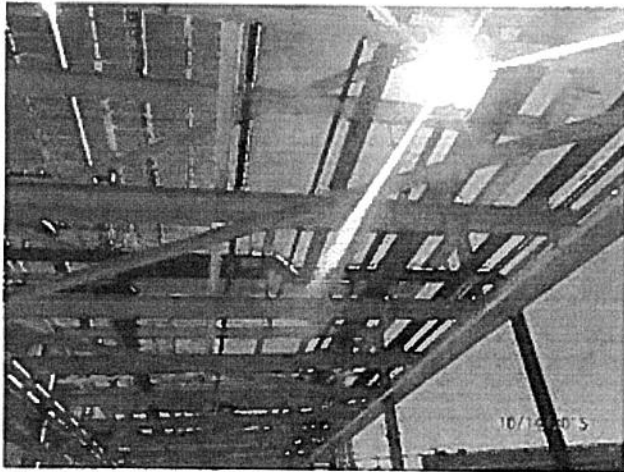
The inspectors observed that the 200 Area Raffinate secondary containment was filled with rainwater. Upon closer examination, it was observed that the secondary containment concrete was etched (Pictures 45-48). The inspectors expressed concern over the etching in the concrete and asked what caused the etching. Mr. Harris explained that overflow of the Raffinate tanks due either to operation error or process issue upset. Mr. Harris indicated that a coating contractor had been obtained and was ready to coat the secondary containment.

The inspectors expressed concern that the in-process material that HHMP is storing is causing etching in the secondary containment system. Secondary containment areas are required to have a base that must underlie the containers which is free of cracks or gaps and is sufficiently impervious to contain leaks, spills, and accumulated precipitation until the collected material is detected and removed. The EPA advised Mr. Harris that releasing the acidic aqueous solution into a permeable structure was not considered to be properly stored and/or contained. The EPA and NC DEQ further explained that the Raffinate secondary containment be re-coated prior to any further releases or upsets.

Picture 48 – Raffinate Area secondary containment with etched concrete under rainwater

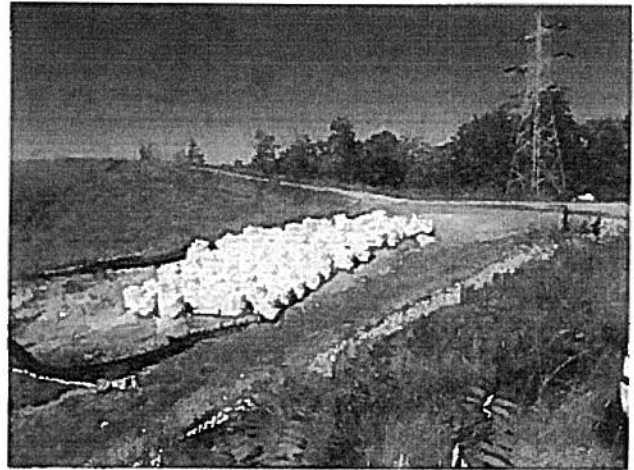
In May 2015, HHMP had a release of depleted solution from a ruptured elbow in the piping. The solution filled the secondary containment before overflowing onto the ground and down the drainage channel (Pictures 49-52). The release was reported as hydrogen sulfide and zinc solution to the National Response Center (Incident Report # 1116915). HHMP neutralized the ground and removed the solution contaminated soil into roll-offs in July 2015.

Picture 49 – Raffinate Area depleted solution pipe that was broken in May 2015

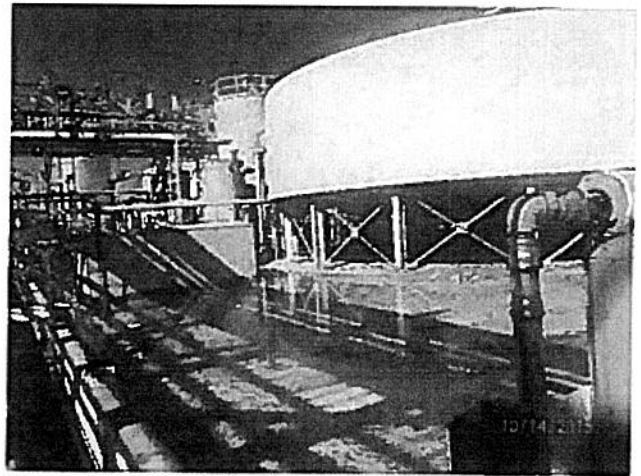
The inspectors observed that the WOX Wash Clarifier secondary containment was filled with rain water and tank overflow material (Pictures 77, 79-85). The ground surrounding the clarifier contained residue dust, mud and rainwater. The area had been recently covered in concrete six months previous.

Picture 81 – WOX Clarifier filled with tank overflow

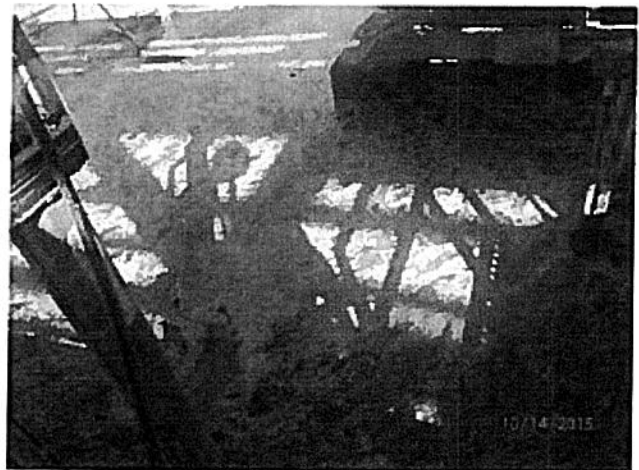
Picture 82 – WOX Clarifier filled with tank overflow

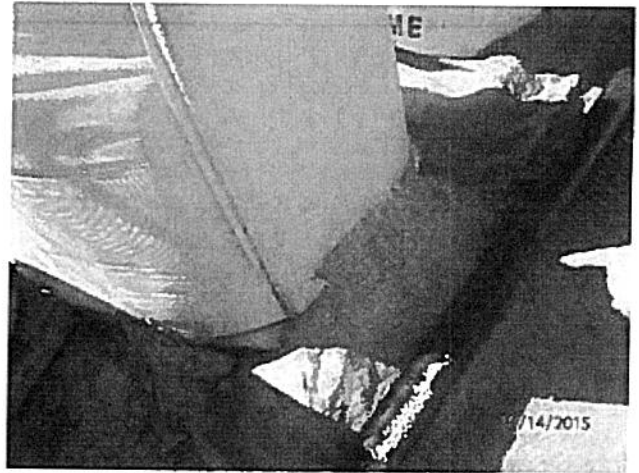
At the time of the inspection, the facility was storing 57 supersacks of spent manganese along the Storm Water Ponds driveway (Pictures 103-105, 108). Mr. Harris explained that the spent manganese was from the cellhouse cleanout and would be sold because of the lead and silver concentrate. The inspectors expressed concern that many of the supersacks were open and none of the bags were labeled as hazardous material prior to shipping out. In addition, the inspectors noted that a broken supersack of high end sand to be used in the sand and carbon filters (Pictures 106-107). The inspectors expressed concern over the management and improper storage of the raw product.

Picture 103 – Process Ponds bags of spent manganese

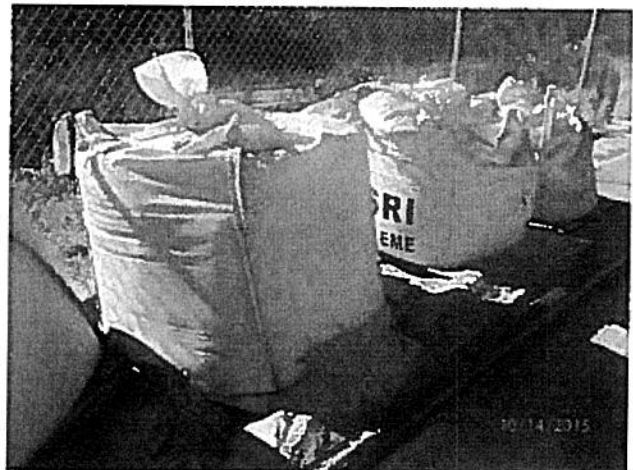
Picture 104 – Process Ponds bags of spent manganese

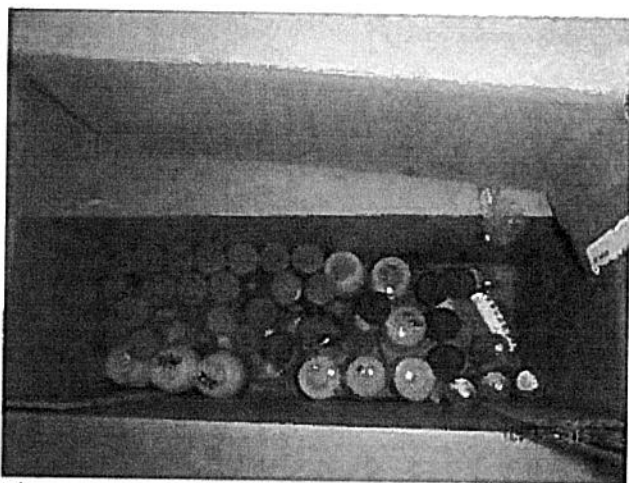
The inspectors toured the Spectrometer Lab and observed used synthetic oil containers waiting to be discarded (Picture 118). Mr. Gilbert explained the oil was being changed out. The bottles were observed not labeled and not kept in secondary containment at the time of the inspection.

Picture 118 – Spectrometer Lab used oil containers

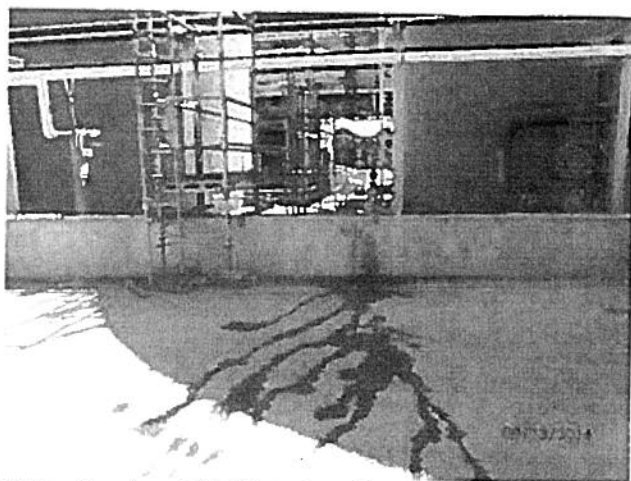
Picture 8 – Area 400 Electrolyte Storage Tanks with secondary containment cracks

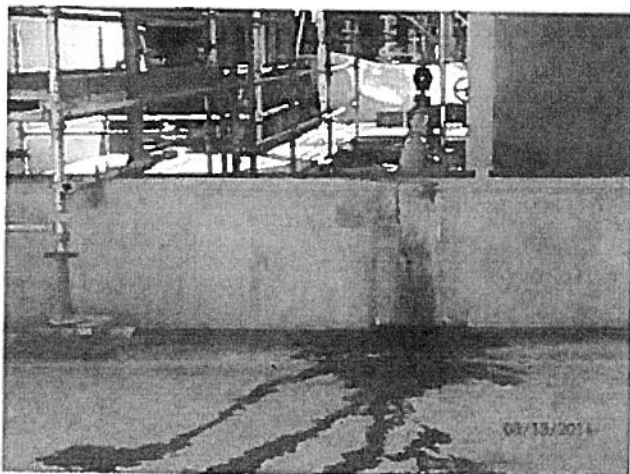
Picture 9 – Area 400 Electrolyte Storage Tanks with

secondary containment cracks

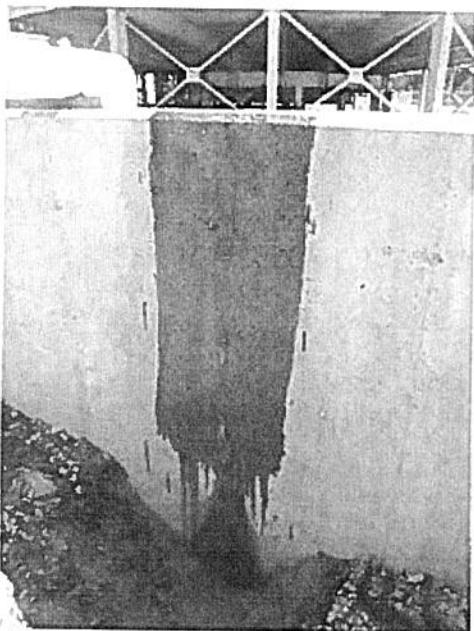
Picture 14 – WOX Clarifier secondary containment crack leaking

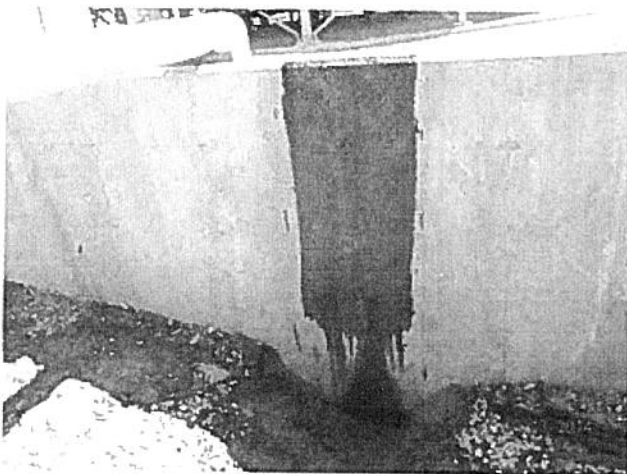
Picture 15 – WOX Clarifier secondary containment crack leaking

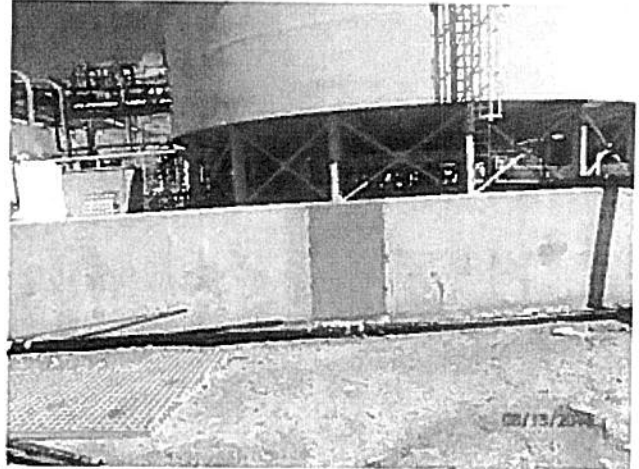
Picture 16 – WOX Clarifier secondary containment crack repaired

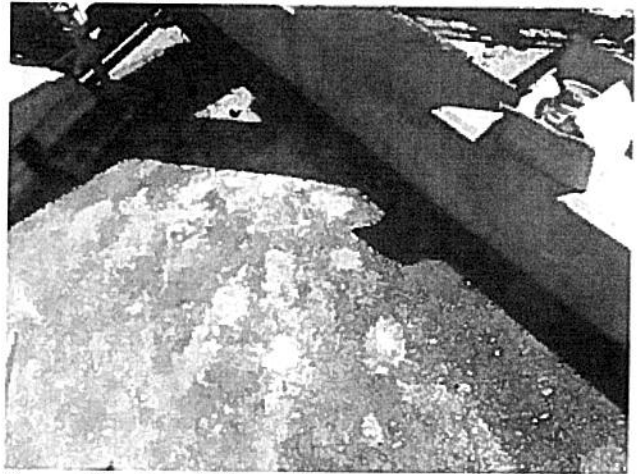
Picture 28 – Area 100 Leaching dried WOX mixture on the ground

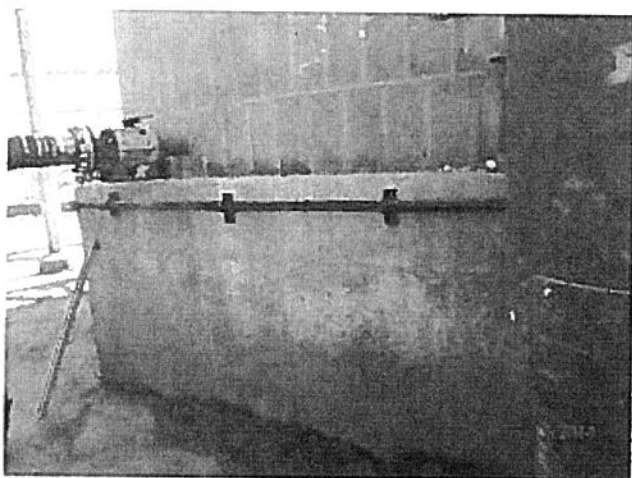
Picture 32 – Area 100 Leaching WOX mixture residual dried on the wall

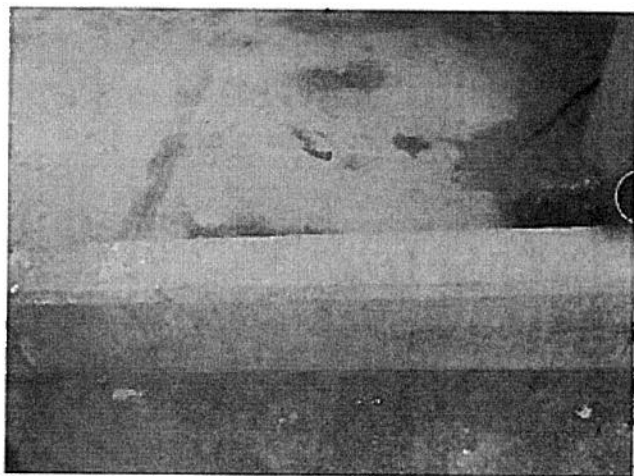
Picture 33 – Area 100 Leaching WOX mixture residual dried on the wall

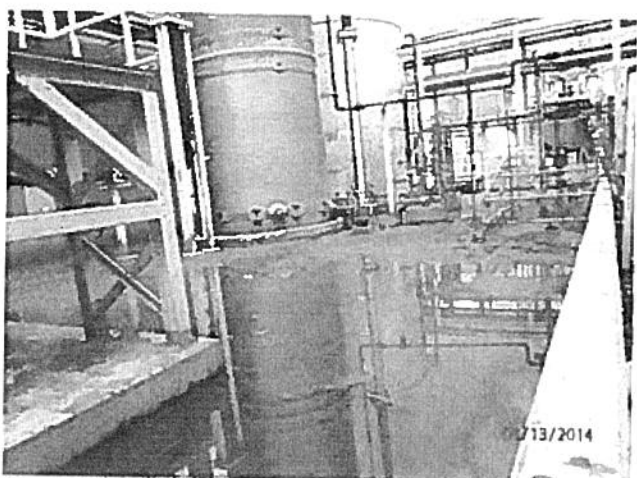
Picture 37 – Area 100A PLS Containment filled with WOX mixture

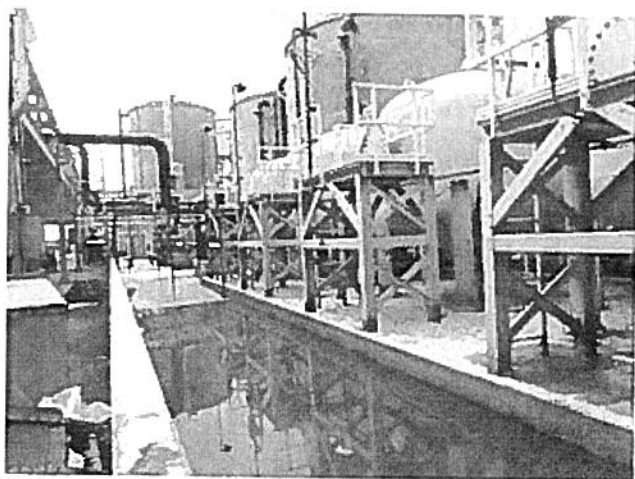
Picture 38 – Area 100A PLS Containment filled with WOX mixture and calcium

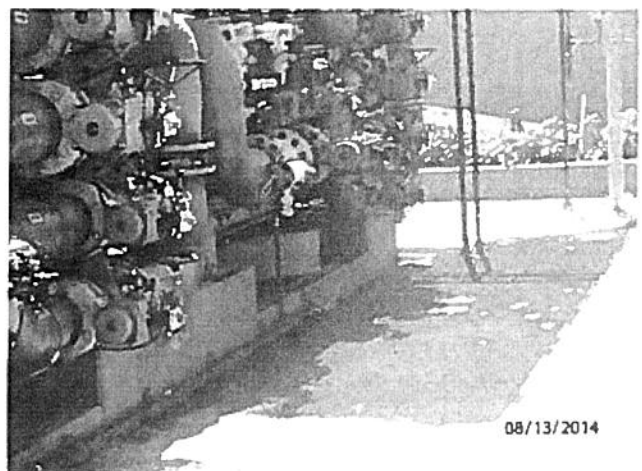
Picture 48 – Carbon Filter Tank lead contaminated carbon inside secondary containment

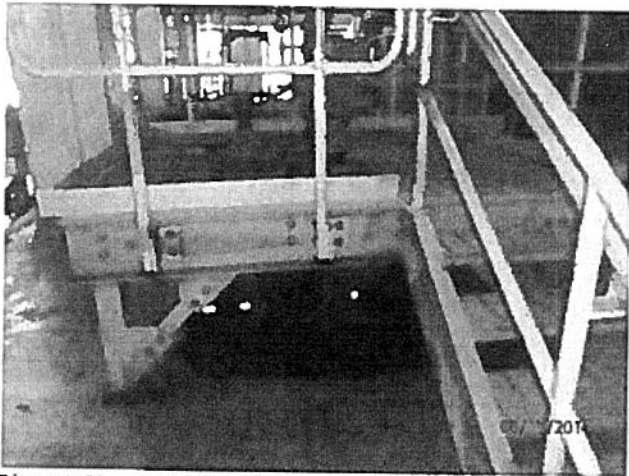
Picture 61 – Area 400 Basement with used oil leak

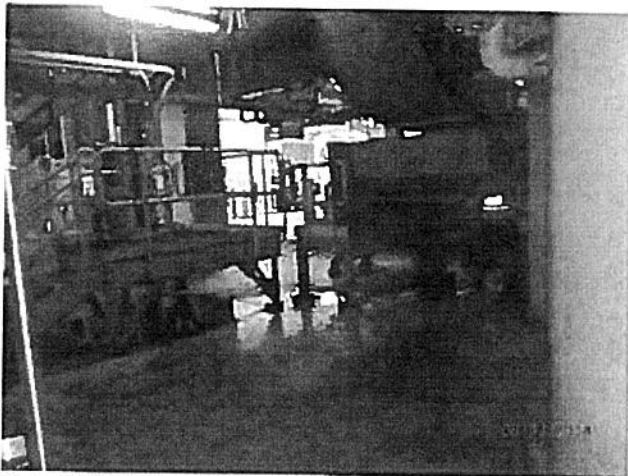
Picture 62 – Area 400 Basement with used oil leak

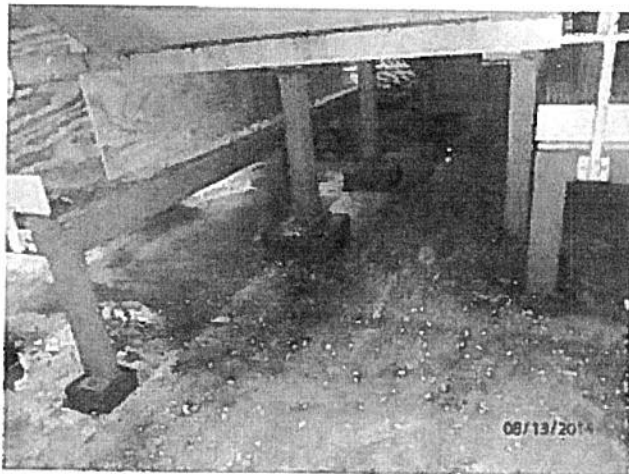
Picture 63 – Area 400 Basement with used oil leak
